BODYSHELL AND CHASSIS REPAIRS

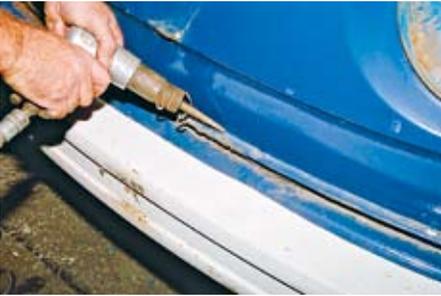
3.6 Cut the old panel into more manageable chunks. I used an air chisel to slice it up, starting with the bottom half, although an angle grinder with cutting disc would be just as effective.

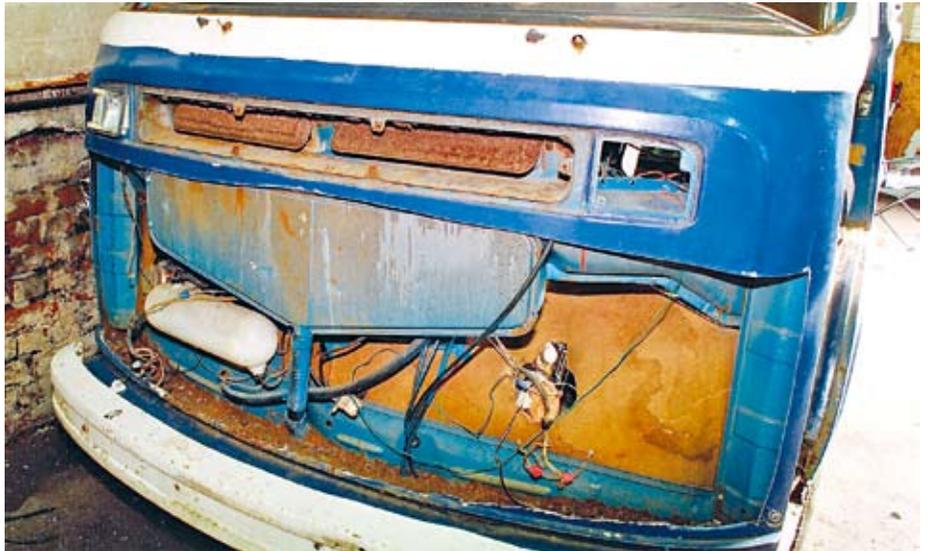
3.7 Once removed it shows how little there is between the cab and the outside world.

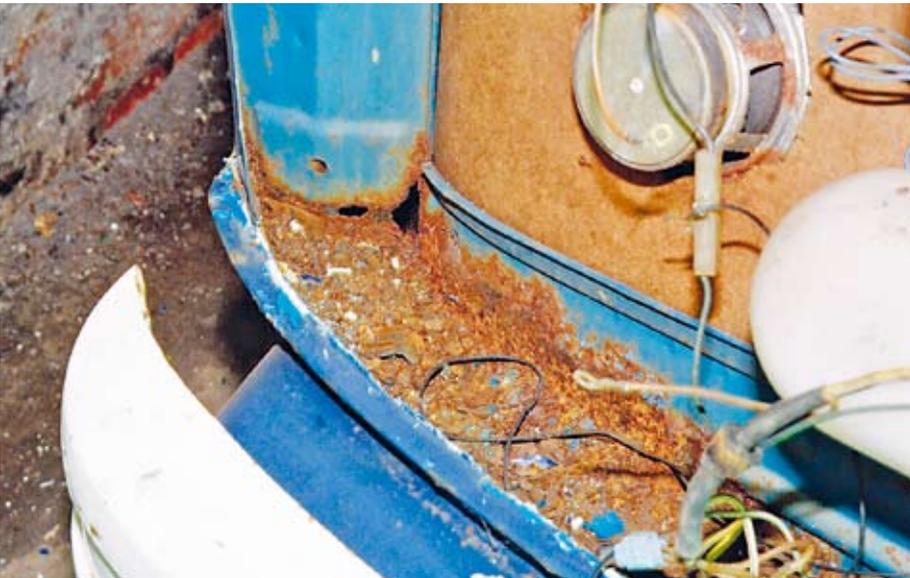
3.8 Expect the inner panel to be corroded and holed, especially in the corners.

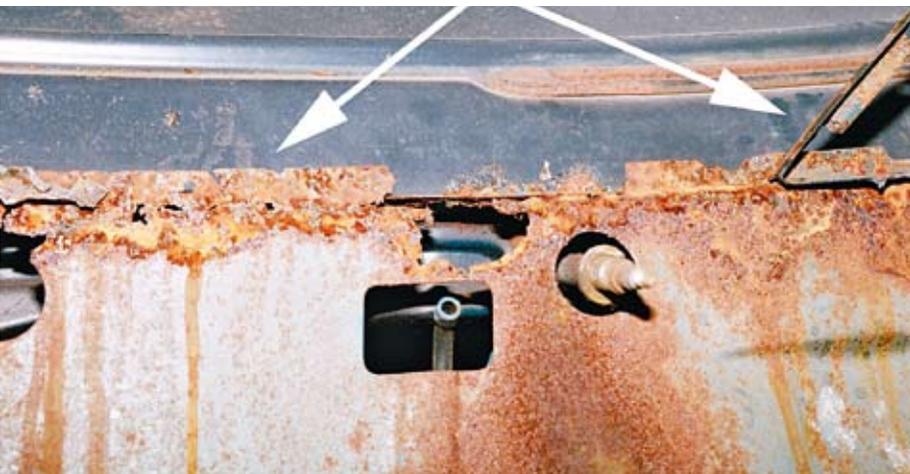
3.10 The join at the screen support panel will almost certainly be rotten.

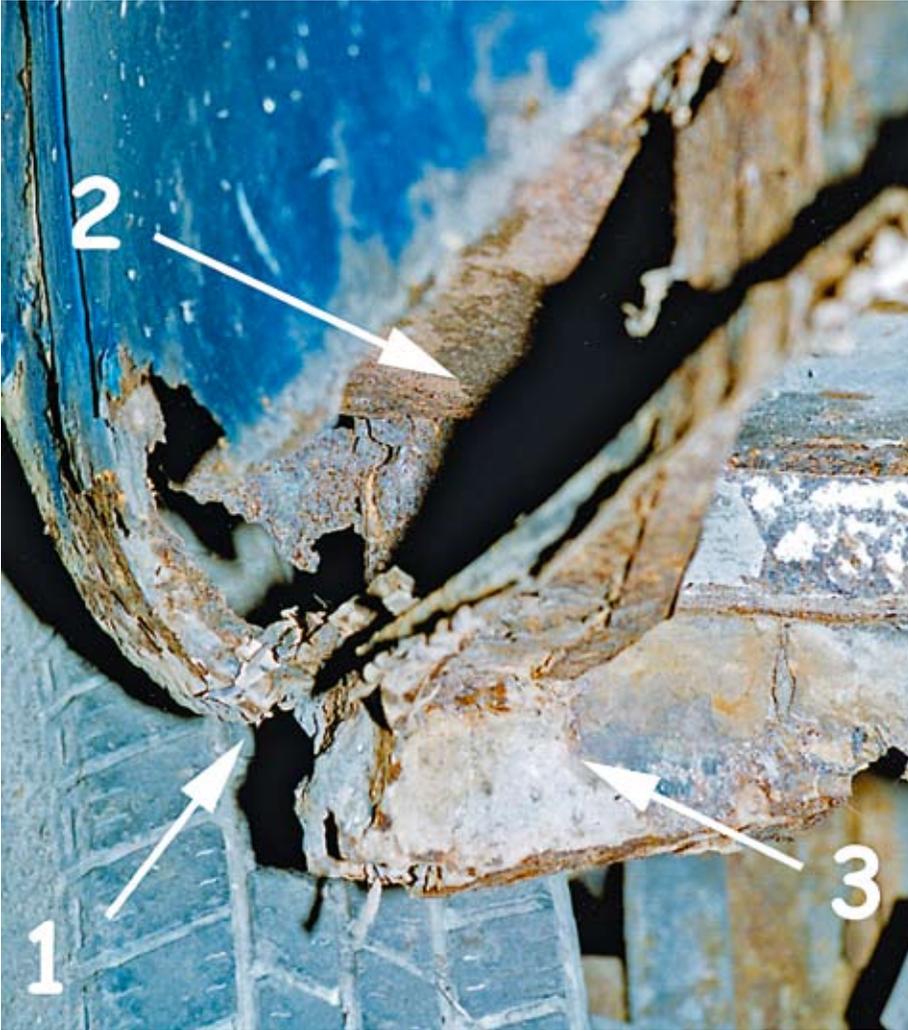
3.97 An exploratory cut below the join to the upper panel may reveal a mess. (1) is the remains of the B-post, (2) the inner sill, and (3) the front outrigger. The middle section is completely missing in this case.

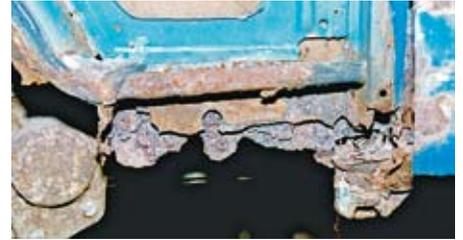
3.98 At the back, this Bus' lack of an outer wing gives a clear view of yet more extensive corrosion.

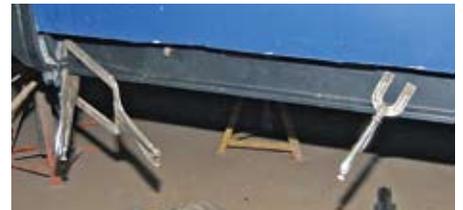
3.100 All of the old sill should be removed. The floor and outriggers on this Bus were rotten so were just chopped out. If yours are fine, then the floor must be drilled to free the spot welds. At least one jacking point has to be removed if you want to fit an inner sill, as it cannot be squeezed in otherwise. However, if the sill is holed, then the outriggers may well be, too. An alternative is to use a cover section if your inner sill is not too badly rotten. The new inner sits on top of the front outrigger, and there is a depression halfway along which matches one in the floor and conveniently sits on top of a floor support, assuming that it's still there. These 2 points allow accurate initial positioning of the new inner, which can then be clamped in place before a few tacks are added to hold it while the rest are made.

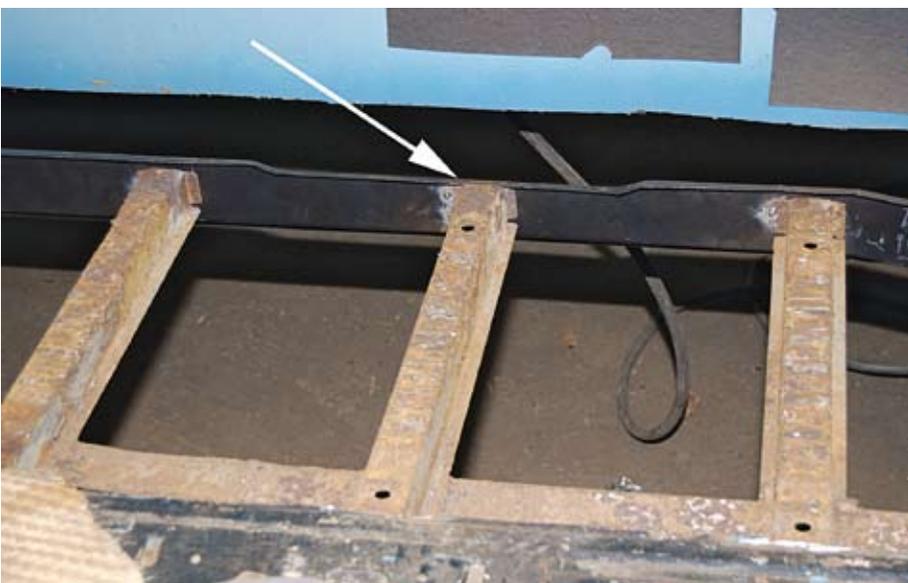
3.101 Here, the new inner can clearly be seen tacked in place, with the floor support meeting the depression (arrowed).

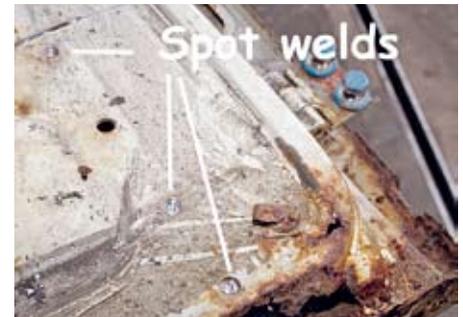
4.13 Further to the right, down by the lower hinge, the frame is spot welded to an inner strengthener. Finding the old welds can be tricky as there may be a lot of scabby corrosion in this area.

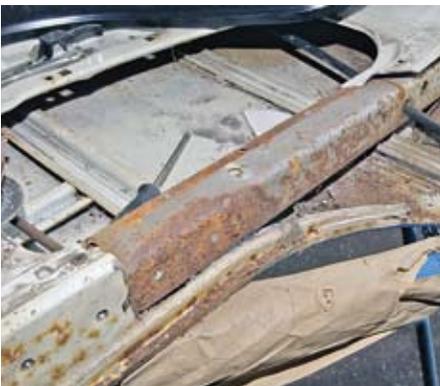
4.15 Here, the frame is partially removed showing the inner strengthener which was, of course, rusty. The last section to the left was about to be removed.

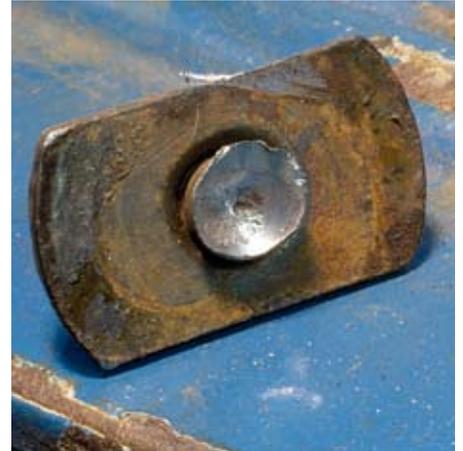
4.64 The removable hinge turned out to be anything but, as the securing bolt was seized solid, so had to have its head drilled off to free the lid.

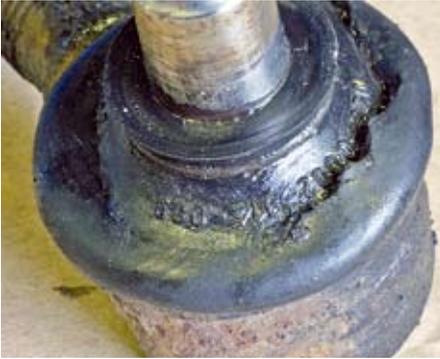
6.44 Removing the lower ball joints will take some effort. Hitting the eye of the hub is unlikely to work so a splitter will have to be used, which will inevitably damage the boots.

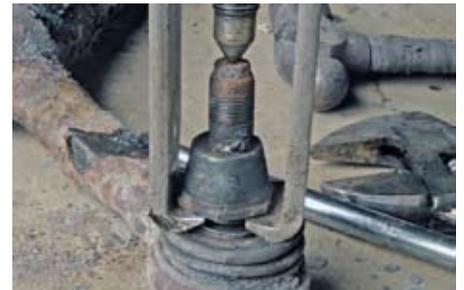
6.47 unfortunately, this is usually because the two bits are corroded together. A puller may be needed to split them.
