# Chapter 1

# Engine will not start from cold

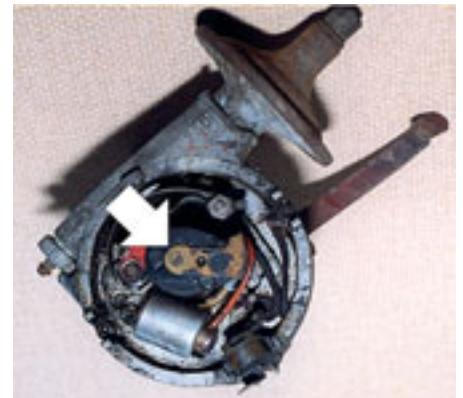
**1-1-1 (Picture 1) Unfortunately, but unavoidably, there are numerous connections within the ignition circuits that can result in a no-start situation. A frequently overlooked but important distributor of the high tension spark is the rotor arm, shown here. The centre terminal (arrowed) must make good contact with the carbon brush in the centre of the distributor cap (see picture 3). This is an early Lucas 25D model distributor which was superseded by the introduction of the rubber bumper cars with...**

With the distributor cap off, check that the rotor arm is clean in the centre

and at its periphery, and that the cap's four internal contacts are not worn, pitted or damaged. Check that the vacuum

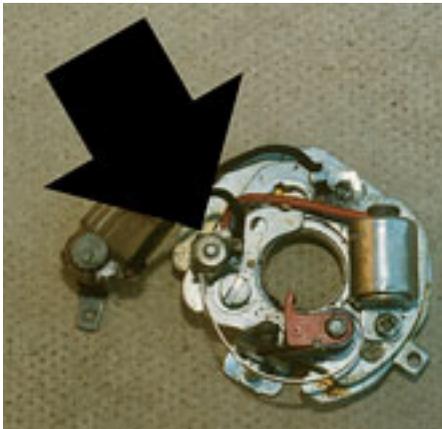
**3-1-3 Changing the condenser and/or points beside the road is no fun, particularly if it's an operation you're unfamiliar with. Many would advocate removing the whole distributor, but I think the job is easier if you've followed my suggested list of spares and have a spare baseplate for the distributor, complete with a serviceable set of points and condenser; they don't have to be new. This baseplate is from the Lucas 25D distributor of an early/chrome bumper car; the 2BA retaining nut (arrowed) gives this fact away. Later cars had a Lucas 45D series distributor with a sliding spring mounting superseding the 2BA nut.**

**3-1-3** If you're experiencing bad (and possibly worsening) engine performance, but the engine does at least keep going, the probability is that the condenser in the distributor is going "open-circuit." In other words it is as if there were no condenser, and the consequence of this type of fault is that the points burn very quickly and that the ignition circuits don't function as well as they were designed to - hence the poor engine performance. Typical

Lift the cap off the distributor and take a careful note of where things go around the distributor's points/condenser. I know you're broken down and are in a hurry to get going again, but if you're not familiar with ignition systems, it really is worth taking a couple of minutes to sketch the routing of the various wires and the order of assembly of the low tension wires and insulator. Note, for example, that you do **not** need to disturb the points unless they are burnt and need changing. Unscrew the crosshead screw that secures the condenser and the top 2BA nut on top of the pillar carefully (it is **very** easy to drop either, or both) and ease up the washer and then the usually white(ish) top hat-shaped insulator. Put both on one side out of harm's way and concentrate on the two ring terminals now left on the pillar. You may find that the condenser's terminal is on the top in which case it is a simple case of just removing the whole condenser and replacing it. If you happen to find the input wire's ring termination on top, lift that gently away for a second, remove the condenser and replace the terminals loosely on the pillar in any convenient order. The next step is one of the key details that must be done correctly. Put the top hat insulator back on the pillar such that it goes **through** the two wiring eyes and the pivot arm of the points and that these three components are insulated from the other low tension ignition components in the area. You should have the flat (wide) top of the insulator looking up at you, ready to accept the washer and 2BA nut - which you'll note can be screwed down but will be insulated from the two ring terminals and the point's pivot. Secure the condenser, put the cap back on the distributor and try the engine.

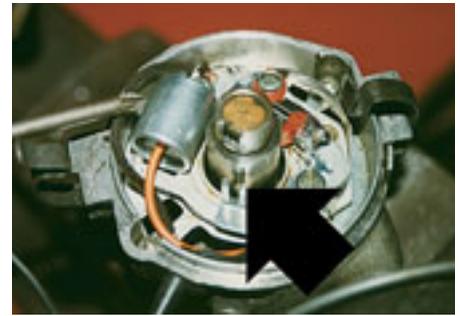
**3-1-4 (Picture 1) This picture shows the condenser (screwdriver points to it), the distributor cam (arrowed) and gives another general view of the Lucas 45D distributor...**

**3-1-4** Even a correctly serviced car can experience problems. A degenerating condenser can burn or "pip" the points and cheap non-original equipment points sometimes have cam-followers made from soft material that wears prematurely. Both

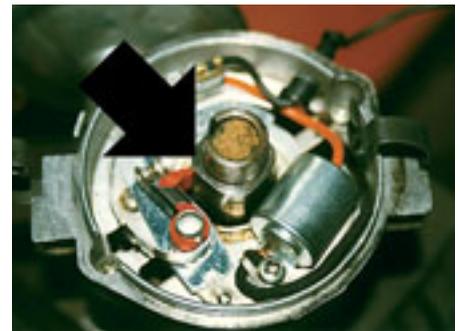
**3-1-4 (Picture 2) ...whilst here we highlight the cam follower or "heel", which can prematurely wear if you fit a cheap contact breaker set and/or fail to lubricate the cam. Note the slot for points adjustment on the 45D.**

reduce the ability of the points to open and close properly. Further, it's possible that the points securing screw was not quite pinched-up tight or even that the car was not properly serviced! Whatever the underlying reason, unless you have electronic ignition (fitted as standard to US MGBs from 1976 and retro-fitted to numerous UK cars of all years) the contact breaker points need to open and close as the distributor's cam rotates. If your car's points have virtually closed up, they will not be making and breaking the primary (low tension) ignition circuit as intended.

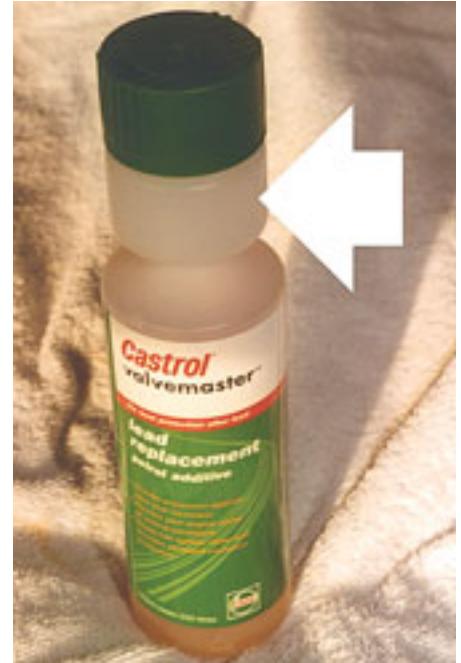
**6-10-1** An example of AWAs (Anti-wear additives) intended to reduce valve seat recession (VSR). The bottle is squeezed until the top measuring part (arrowed) is filled.

**6-10-1** If tappet rattle returns or increases within a relatively short distance (say 3 or 4000 miles) of adjusting the valve clearances the engine could, in these days of lead-free fuels, be suffering from valve seat recession (VSR) and you need to be alert to this possibility. While this does not help those readers outside the UK, nevertheless many may be interested, even surprised to learn that leaded petrol is still available from certain retailers around the UK and that the list is growing all the time. The coverage is national and there should be at least one source in every reasonably sized town. If this interests you and is a potential solution to your VSR, take a look at <[www.bayfordthrust.co.uk](http://www.bayfordthrust.co.uk)>. The first corrective step is to re-adjust the tappets and, I suggest, you make a note somewhere as to the recorded mileage. If you're fairly sure that the car's cylinder head has not been modified for the use

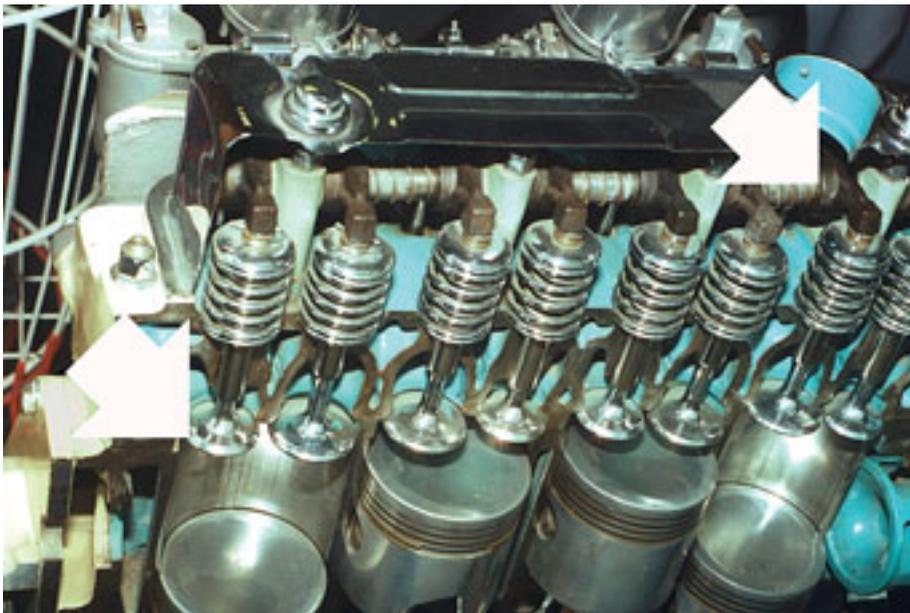
**6-9-1** The rocker shaft and bearing (arrowed) that eventually wears. The shaft and this bearing work under the constant upward pressure of the valve springs, so some wear is inevitable over time. Not related, but also highlighted is a valve seat: these need to be harder in an engine using unleaded fuels (see 6-10-1).

**6-9-1** If the engine still has very noisy top end even after adjusting the tappets, the engine probably has a worn rocker shaft and/or worn rockers. As you may have guessed, it is not the valve contact faces of the rockers that have worn, but rather the rocker bores such that they are slopping about and thus rattling on the (probably also worn) shaft on which they pivot. This would not be an unusual problem by any means.

To check, remove the rocker cover, the four retaining nuts and remove the rocker shaft assembly complete. Each rocker should pivot on the shaft without restriction but there should be no obvious clearance between any rocker and its shaft. In this circumstance you should expect to find several if not all rockers can be moved up/down on the shaft signifying excessive clearance between rockers and shaft due to wear.

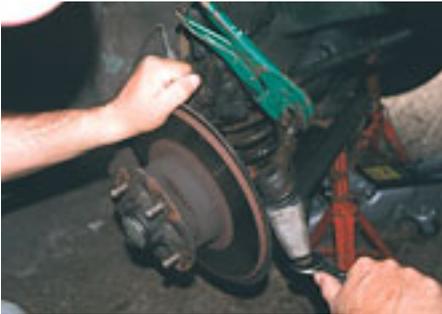
**10-11-1 (Picture 3)...**and almost certainly will need a ball joint splitter to...

gaiters/boots (the rubber bellows at each end of the rack) for cracks or holes from which oil may have leaked. If necessary, change the gaiters. Although not necessary to remove the steering rack, the ball joints at each end of the rack must be removed in order to slip the new gaiters onto the end of the rack - which, unfortunately, will upset the tracking (more on this shortly).

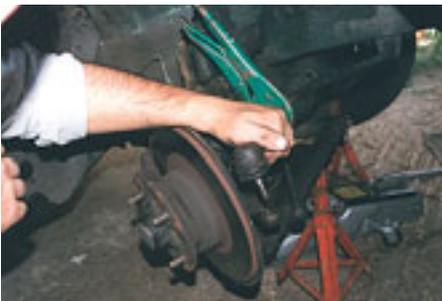
**10-11-1 (Picture 4) ...**separate the tapered shoulder on the ball joint from the track control arm.

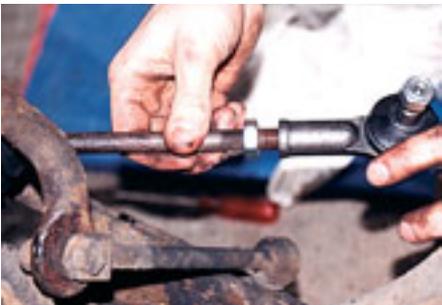
**10-11-1 (Picture 5)** Count the number of turns off the trackrod for each ball joint, and the number back on again, although it's still best to get the tracking checked afterward.

of the ball joints and replicated that after fitting the new gaiters, the resultant wheel tracking should not be too inaccurate. Try the car for a few days and, if there's an improvement, get it professionally tracked. If no improvement, it's time to consider the rack itself.

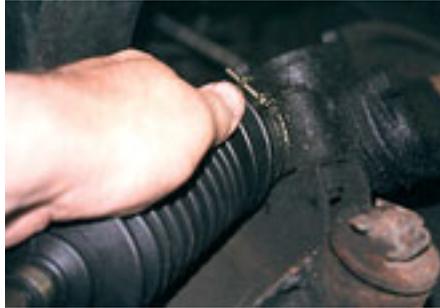
**10-11-1 (Picture 6)** Once the inner end of the gaiter is secured to the rack with the clip supplied in most gaiter kits...

rack with the recommended oil. This is most easily achieved by jacking the car so that it is tilted sideways, and releasing the clamp that secures the gaiter to the track rod (usually a plastic tie), and syringing in the oil. Refasten the open end of the gaiter to achieve an oil-tight seal.

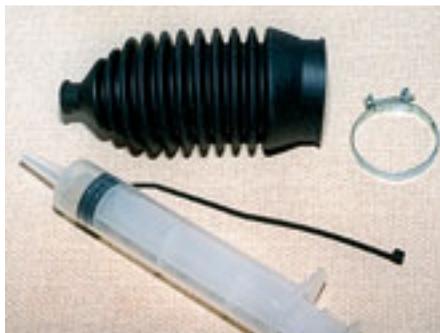
**10-11-1 (Picture 7) ...**a syringe will be necessary to inject the (thickish) EP90 oil into the rack through the small end of the gaiter. You may or may not get a cable tie-type clip in your kit...

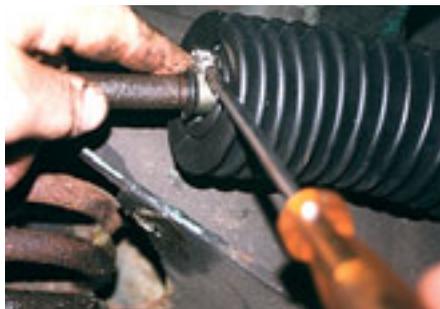
**10-11-1 (Picture 8) ...**but one will be necessary to seal the small end of the gaiter to the trackrod.

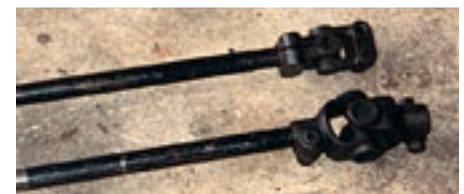
**10-12-1** You may find the differences between the larger chrome bumper universal joint (nearest the camera) and a rubber bumper steering rack interesting.

**10-12-1** Play in the steering can also cause the car to wander, with the almost inevitable over-correction making the problem worse. This play is the result of wear within either the steering rack or the universal joint (UJ) within the steering column. You should be able to feel the play/lash at the steering wheel when the car is stationary, and also notice, when in motion, that turning the wheel slightly has little or no effect on direction.

Check the universal joint by having a helper turn the steering wheel from side-to-side whilst you watch the UJ for (tiny) flexing movements. They may be small

and seem insignificant, but remember that wear in the UJ is multiplied several fold by the time the rim of the steering wheel is reached. Feel for movement in the UJ, (**Warning!** - you need to be sure your partner does not turn the steering wheel too far or too quickly thus trapping your hand!) If the UJ is worn it's easily replaced, although you'll have to drop the rack forwards for a few minutes by removing it from the front crossmember.

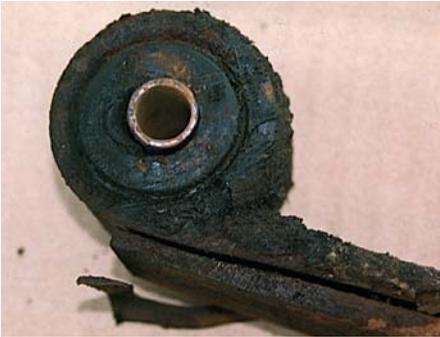
12-8-1 (Picture 3) It looks as if this central tube has separated from its bonded rubber bush, and certainly needs replacing. Since the spring also looks well used, this is clearly a case for a new pair of rear springs.

they've perished and are neither locating the rear axle as you would wish nor providing the cushioned spring movement important to reasonably silent rear suspension. If an eye bush has perished you'll need to replace **both** rear springs. The springs come with new bushes in place and will transform the drivability of your car if the old springs were "past it".

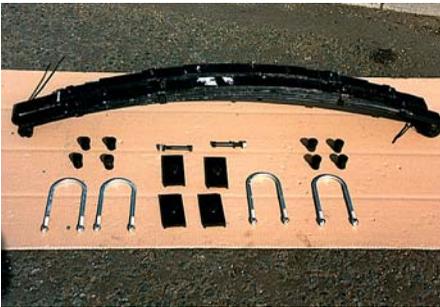
12-8-1 (Picture 4) Order a complete kit, as shown here. Safely support both car and axle, and change one spring at a time.

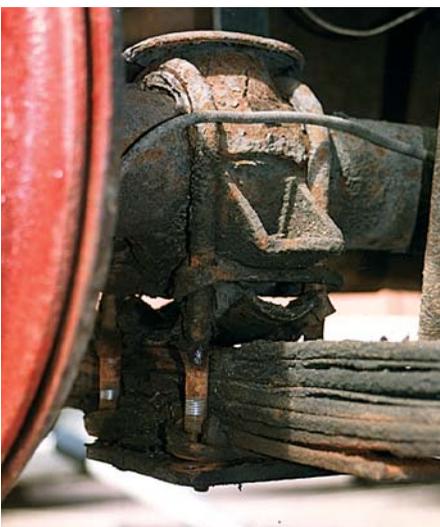
12-8-1 (Picture 5) In addition to the front eye fastening, remove the two U-bolts...

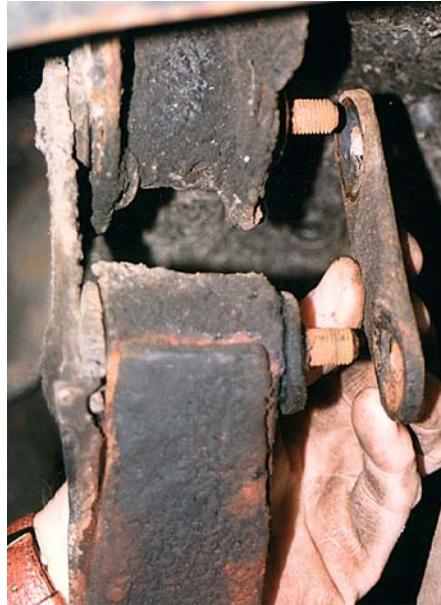
12-8-1 (Picture 6) ...and the rear shackle, seen here with the sideplate removed.

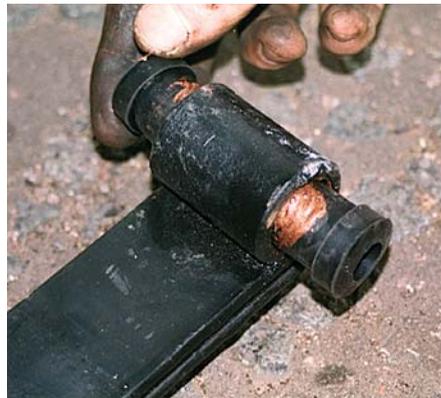
12-8-1 (Picture 7) Use lots of copper-based grease at every stage of reassembly, and remember that the springs are heavy; get help to offer up each replacement.

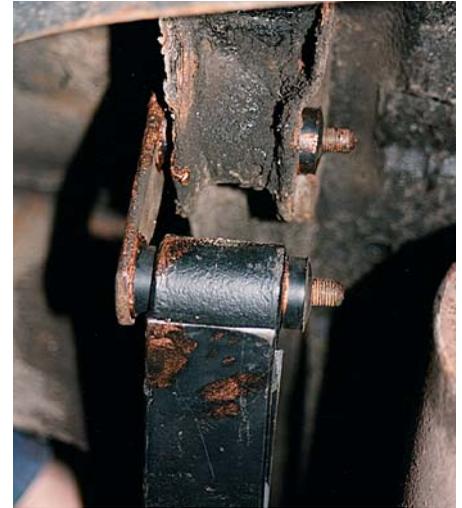
12-8-1 (Picture 8) You may need to compress the spring to lengthen it sufficiently to get the shackle into place (before fitting the plate)...

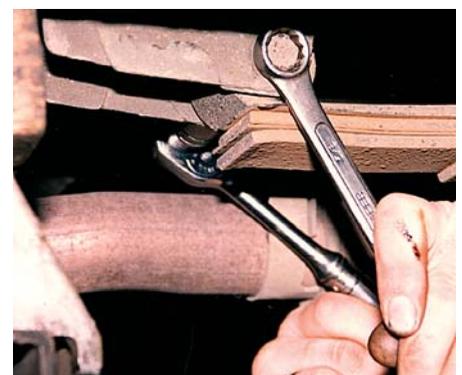
12-8-1 (Picture 10) ...Finally, tighten the eye bolt with the car's weight on the axle.
