## HOW TO RESTORE KAWASAKI Z1, Z/KZ900 & Z/KZ1000

# Chapter 29

## Reassembling the gear change & gearbox cover

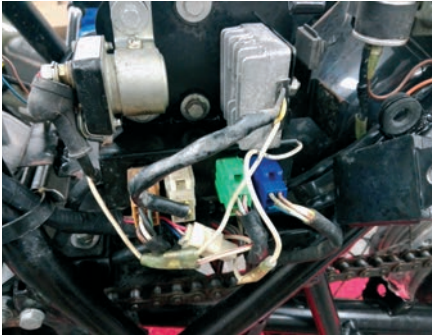
7.4 Junction box in place for reference.

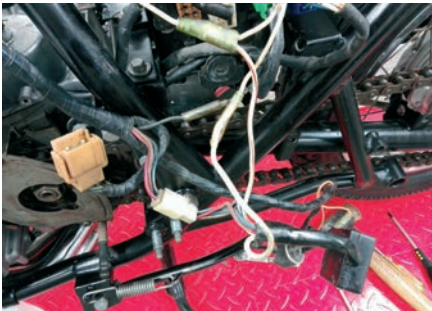
7.5 Main electrics being stripped out.

See photo 7.5 of the main units being stripped out. This mess of spaghetti gives a good indication of why taking lots of dismantling photos is so important!

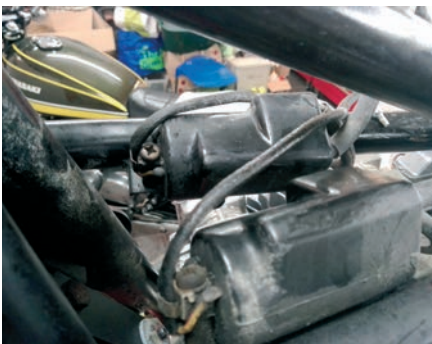
7.6 Ignition coils in situ under the tank.

the bike I then removed the ignition coils. These are bolted to the top rails under the petrol tank (see photo 7.6), which can apparently give rise to them cracking due to vibration, resulting in strange ignition problems. Mine looked to be okay, however, and I removed them from the bike, labelled them, and stored them with the other components. See photo 7.7. At this stage I was unsure whether or not to replace them with new or updated units, but, in the end, replaced them with new, as closer inspection showed the originals to be unserviceable.

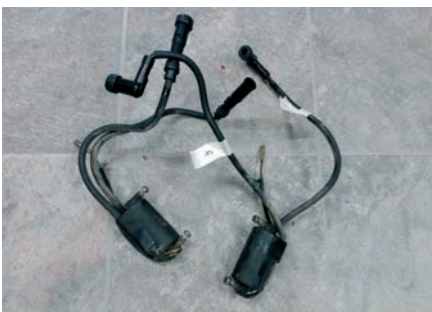
7.7 Ignition coils removed and labelled.

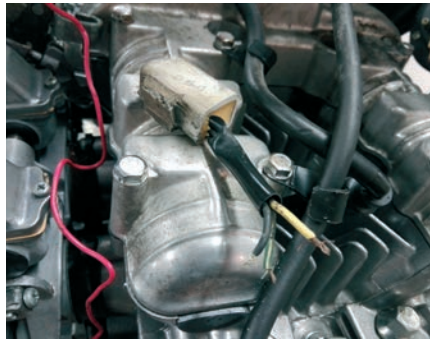
7.8 This strange unit had been disconnected and left hanging – but what was it? (The rear brake light failure switch, it turns out).

discovered a small component that had clearly been disconnected in the past and just left hanging (thankfully), though I had no idea what it was. I later discovered that this was the rear brake light failure switch, which is currently unobtainable, but without which the brake light failure warning light on the instrument panel won't work, so I was very glad it was still there! See photo 7.8.

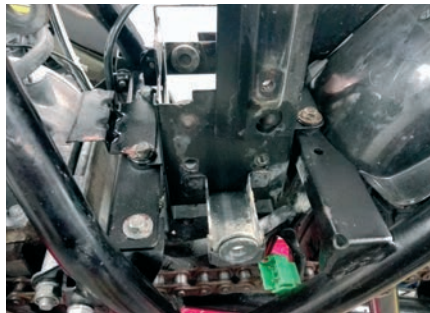
7.9 Left-hand side of battery carrier assembly before dismantling.

This now left a Meccano set of bracketry between the rear of the engine and the back wheel. See photos 7.9 and 7.10. This assembly is held together with the usual assortment of cross-headed screws and 10mm bolts, and came apart quite easily, although the whole thing seemed over-elaborate.

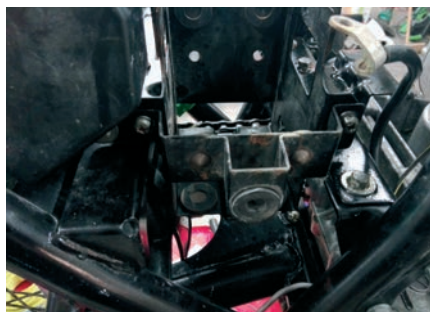
7.10 Right-hand side of battery carrier assembly.

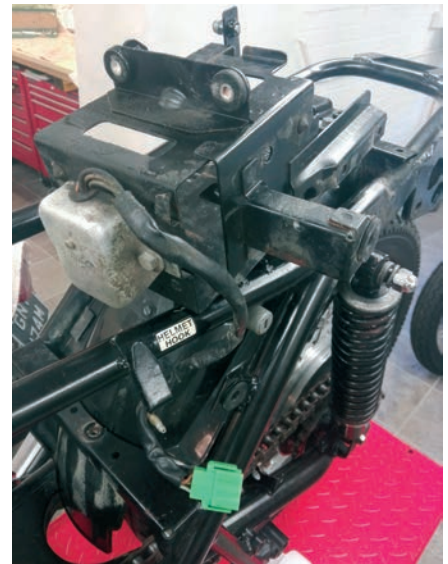
7.11 Rectifier bolted to bottom of battery carrier.

After much removing of screws and bolts, the battery carrier came away, with the rectifier screwed to the bottom of it. See photo 7.11. The battery carrier assembly was now

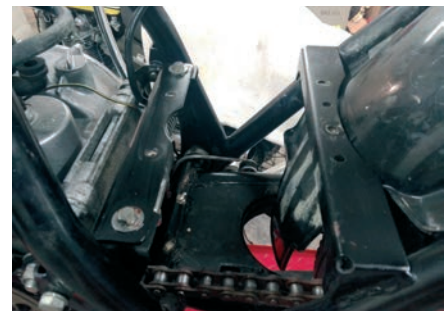
7.12 Battery carrier assembly removed.

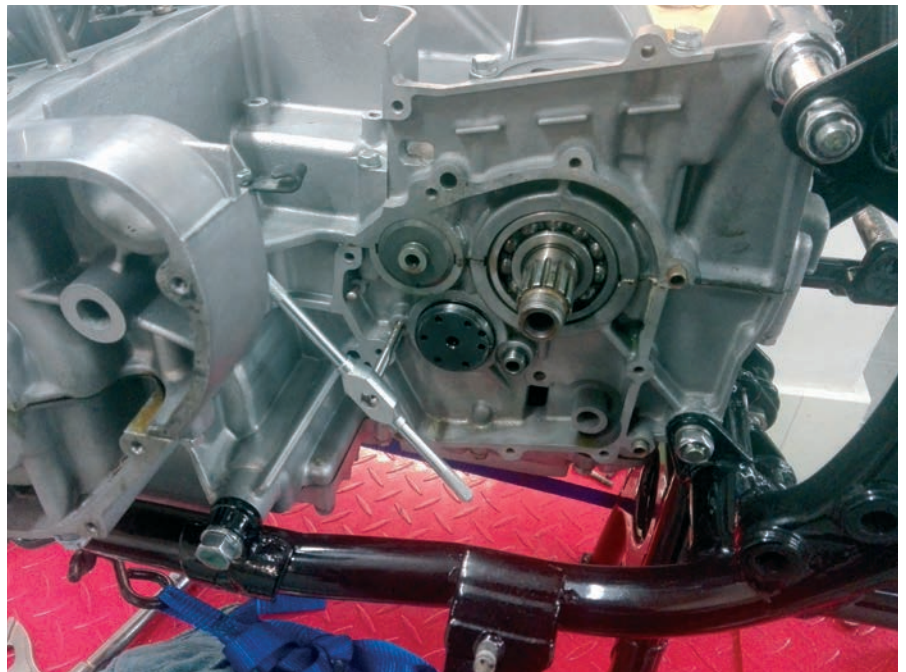
29.1 Tapping out the threads in the gearbox casing.

Next on the agenda were the gear selector mechanism and gearbox cover. My first job (as ever) was to run a tap down the threads which I had neglected to do before – when it would have been so much easier. See photo 29.1. After this I inserted the pins in the gear change drum, with the long pin in the position shown in photo 29.2. I was a bit confused because I was pretty sure the long pin and the gear change drum itself were in the correct position, but a diagram in the *Kawasaki Workshop Manual* clearly shows it being in a different position. Eventually, I found another diagram in the same manual which suggested that the position I had the drum and long pin in was correct so I went with it. Not very reassuring, though. Note that the longer pin is what operates the neutral switch, so it should align with the neutral switch in the outer cover.

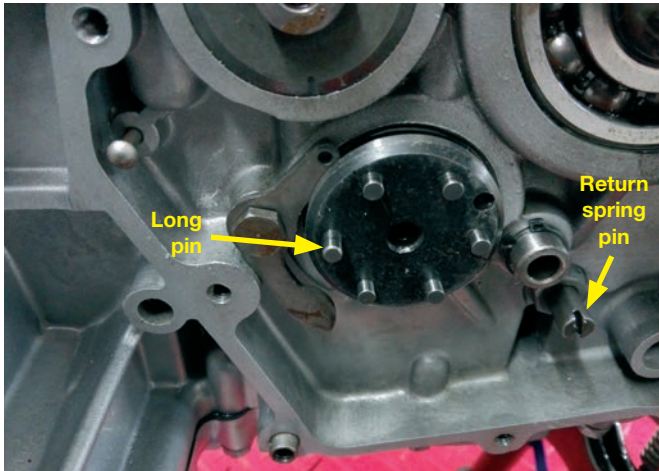
29.2 Refitting the pins in the gearbox drum. The return spring pin was also fitted and locked.

29.4. Having already fitted the return spring pin that the hair spring on the mechanism engages with (see photo 29.2 again), I fitted the pawl mechanism to the casing. The long arms of the pawls engage with the pins in the gear change drum and

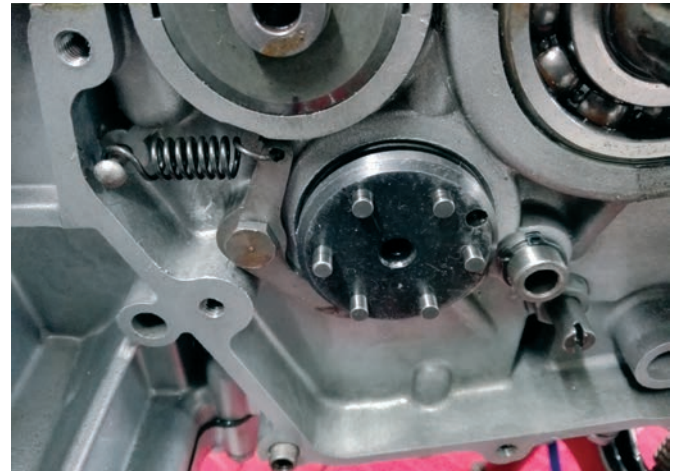
29.3 Detent lever and spring in position.

With the pins inserted I fitted the small detent lever and its spring (which I had checked to see if it had stretched beyond recommended limits, as per the workshop manual), to the left of the gear change drum, ensuring that the lever was free to move on its shouldered mounting bolt. See photo 29.3. This photo also

shows the correct position of the spring, with the end of the spring to the outside of its retaining pin, not the inside.

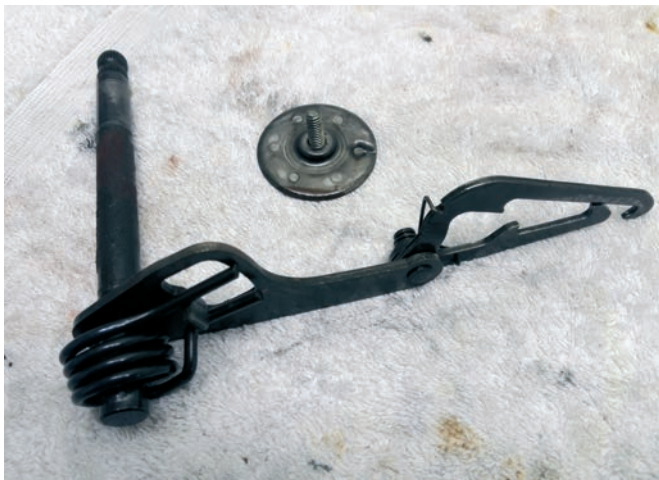
29.4 The gearchange shaft and pawl mechanism.

I cleaned and checked the gear shaft and pawl mechanism and gear change drum cover plate. See photo

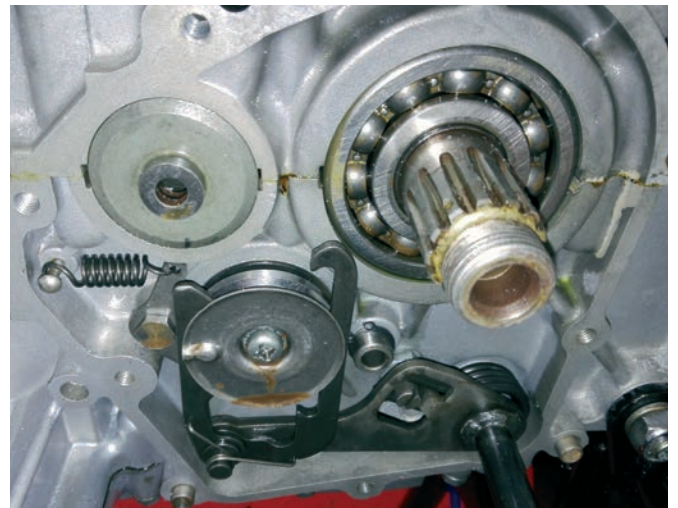
29.5 Gearchange shaft in place, along with the 'O' ring on the main shaft.

turn it to change gear. I also fitted the drum cover plate to the gear change drum with the protrusion in the cover over the long pin. This protrusion is what presses on the neutral switch. I also fitted the 'O' ring seal on the gear shaft just in front of the bearing, without which the gearbox will leak. See photo 29.5.

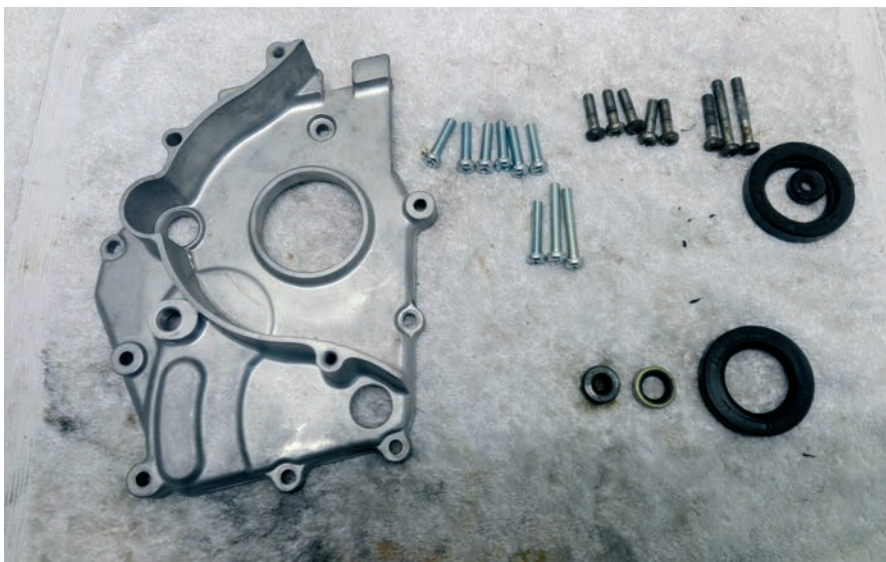
29.6 Gearbox casing with set screws and seals ready to be inserted.

I then assembled the new crosshead screws and oil seals for the gearbox cover (see photo 29.6) before inserting the seals in the cover using my normal method of heating the casing slightly, lubricating the outside edge of the seal, and driving it home with a suitably sized socket and lump hammer (NB oil seals always fit with their innards toward the oil and their flat faces outward), applying Wellseal prior to
