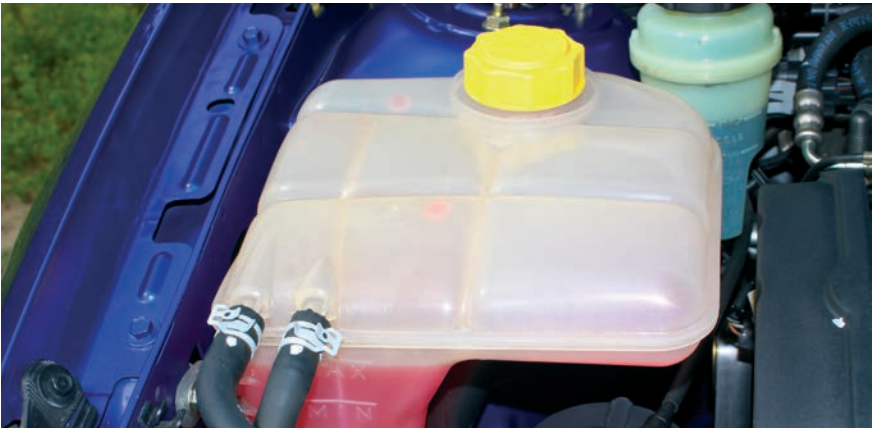
Coolant leaks are common, so check the fluid levels and examine the hoses.

Coolant leaks are common to ST and RS, although the latter causes more concern – and cost. Both are prone to leaks from O-rings on the thermostat housing or cracks in the body, leaving rusty water stains or drips down the bellhousing. The fix is a good-quality new housing or – better still – a billet alloy upgrade.

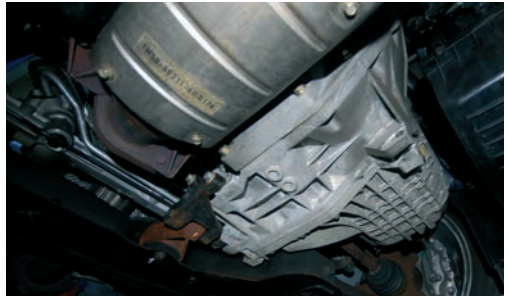
RS transmission incorporates limited-slip differential; check 'box for worn synchromesh.

The MTX75 is man enough for almost any abuse (or power increases), although over-enthusiastic stick-shifting sometimes leads to synchromesh failure: listen for crunching when changing gear, particularly on second and third; an early warning sign is snatching when going into third.

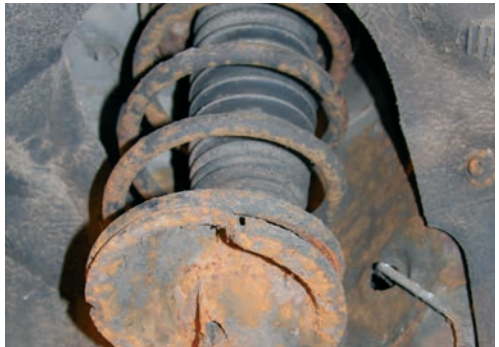
ST170 front springs have a tendency to snap, but this may not be noticed on an initial inspection.

The Mk1 should have a slightly nose-down stance, but tired coil springs tend to lower the rear end and create a floppy ride. Snapped springs are also pretty common.

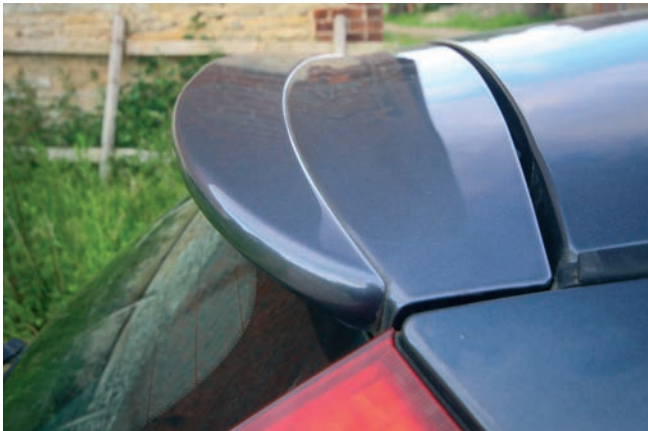
Rear spoiler wasn't standard equipment on the basic ST170.

fact, it was a (widely-specified) optional extra on the ST170, so don't be concerned if it's not on the car you're viewing.

The RS had a larger version of the spoiler as standard. Paint can sometimes craze, which will need stripping and respraying.

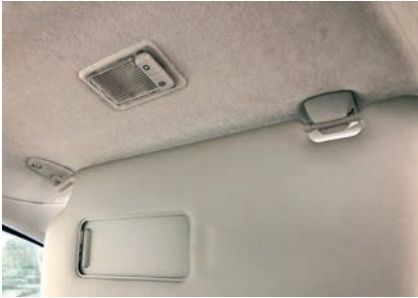
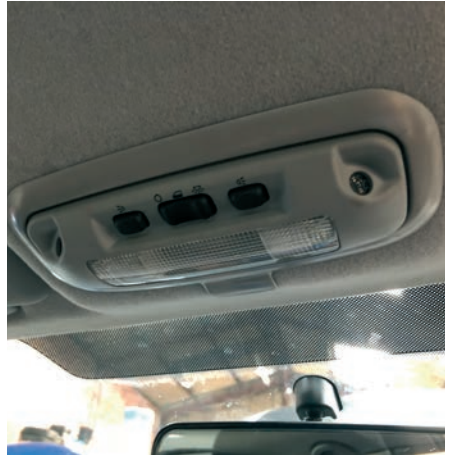
The ST170's improved interior lighting may have been retrofitted to an RS.

The ST170 centre console features a button to disable either traction control or ESP (Electronic Stability Programme), which was an optional extra. Traction control shows a diagram of a car wheel spinning, while ESP highlights a car skidding; there should be a corresponding light in the instrument display when the button is pressed.

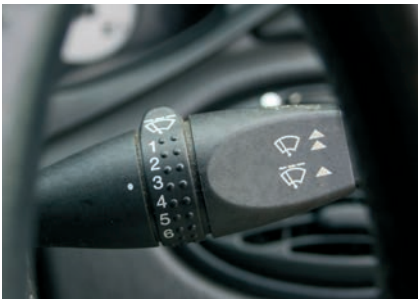
ST170 variable-speed wiper stalk may be retrofitted to RS.

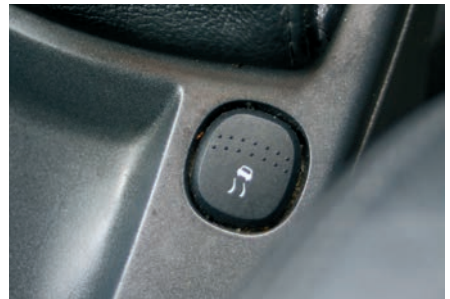
ST170 has TC or ESP button to disable the system.

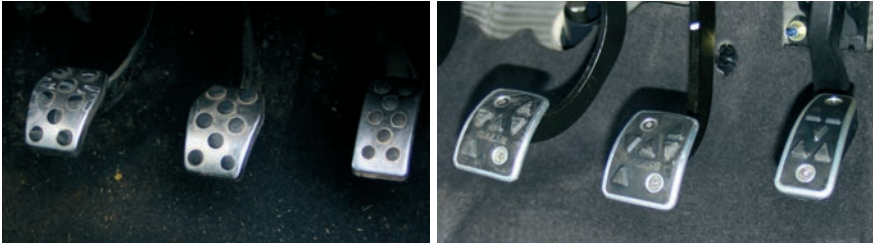
The rubber-studded aluminium ST170 pedals. RS's should have Sparco branding.

The ST170 and RS have aluminium pedal covers, but the RS's should have Sparco branding.

The ST is prone to a vibrating accelerator pedal when driving – particularly at high revs. The usual fix is a new throttle cable. You might also find the pedal is sticking after you lift off the gas. Again, a new cable could be the cure, although cleaning the throttle body butterfly flap may be a cheap and simple solution.
