BODYSHELL AND CHASSIS REPAIRS

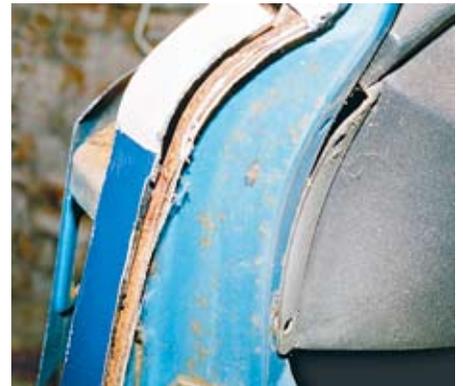
3.9 Grind carefully at 45 degrees to the edge of the panel to free the wrap over from the A-posts.

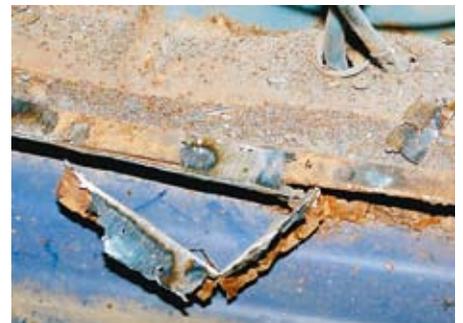
3.11 The tidying up process starts at the bottom. The spot welds may be hard to see so use a grinder to destroy them rather than trying to drill them out. Exactly the same process can be used around the fresh air intake box to free it.

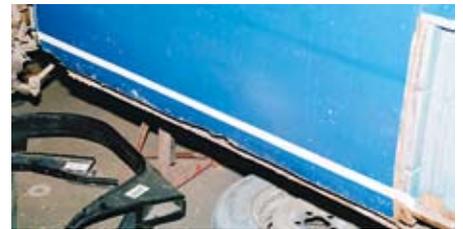
3.99 The side panel should be trimmed back above the level of the rot for the moment. A length of masking tape ensures a straight edge to work to.

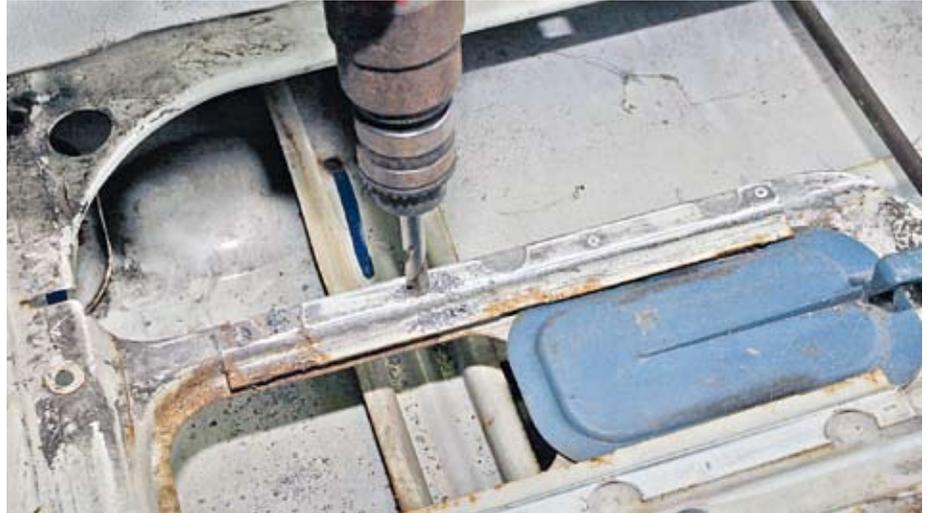
4.11 The new section included the lower door vents (not on all versions), and the flaps are held by a pair of runners spot welded to the frame, which allows them to slide fore and aft. These welds were drilled out to free the metal strips.

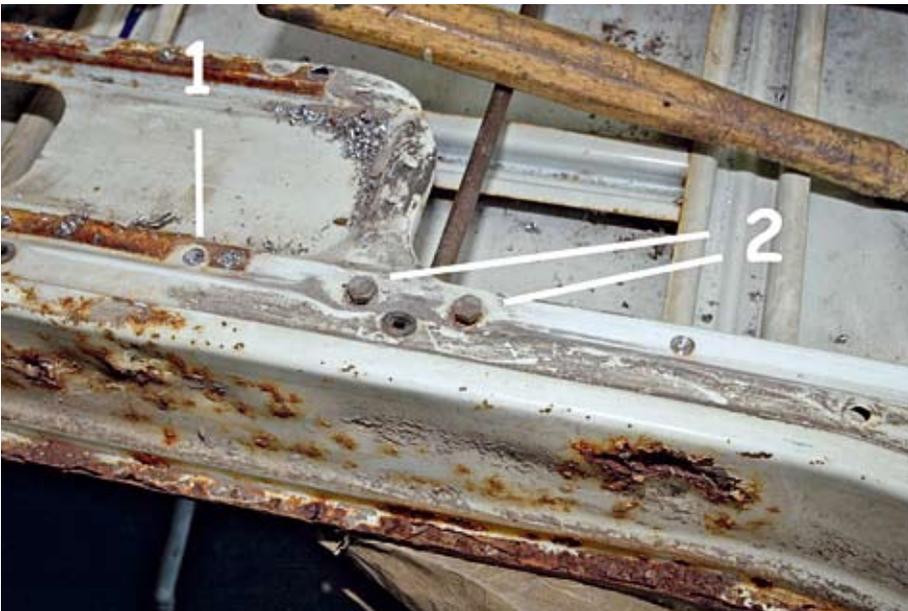
4.12 Just to the right of the removed flaps, indicated by the drilled weld (arrow 1), there are 2 bolts (arrow 2) that pass through the frame and secure the bottom of the window regulator mechanism, which have to be removed.

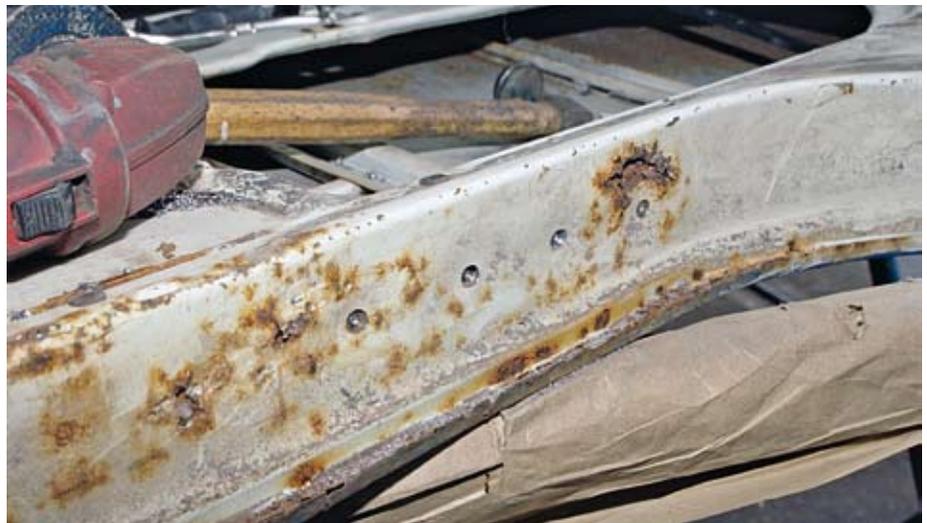
4.15 Here, the frame is partially removed showing the inner strengthener which was, of course, rusty. The last section to the left was about to be removed.

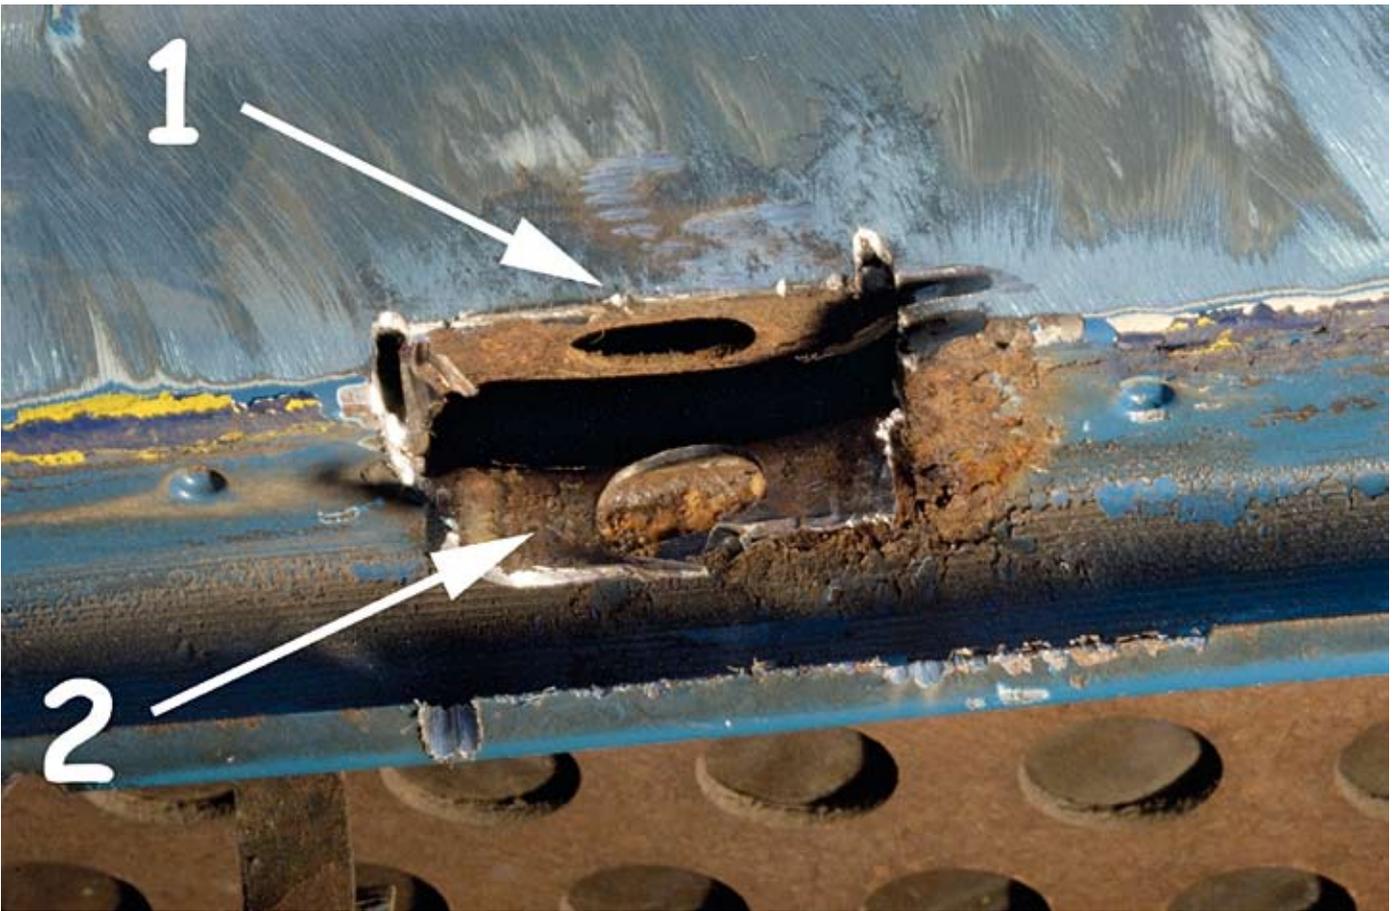
4.65 Unfortunately, the bolt sat in a captive plate which had a degree of free movement to allow for alignment of the lid, so a flap (2) had to be cut from the surrounding steel (1) to get the plate out complete with the remains of the bolt .

4.64 The removable hinge turned out to be anything but, as the securing bolt was seized solid, so had to have its head drilled off to free the lid.

4.66 Once out, pliers were used to free it from the plate and then it was all welded back up once more.

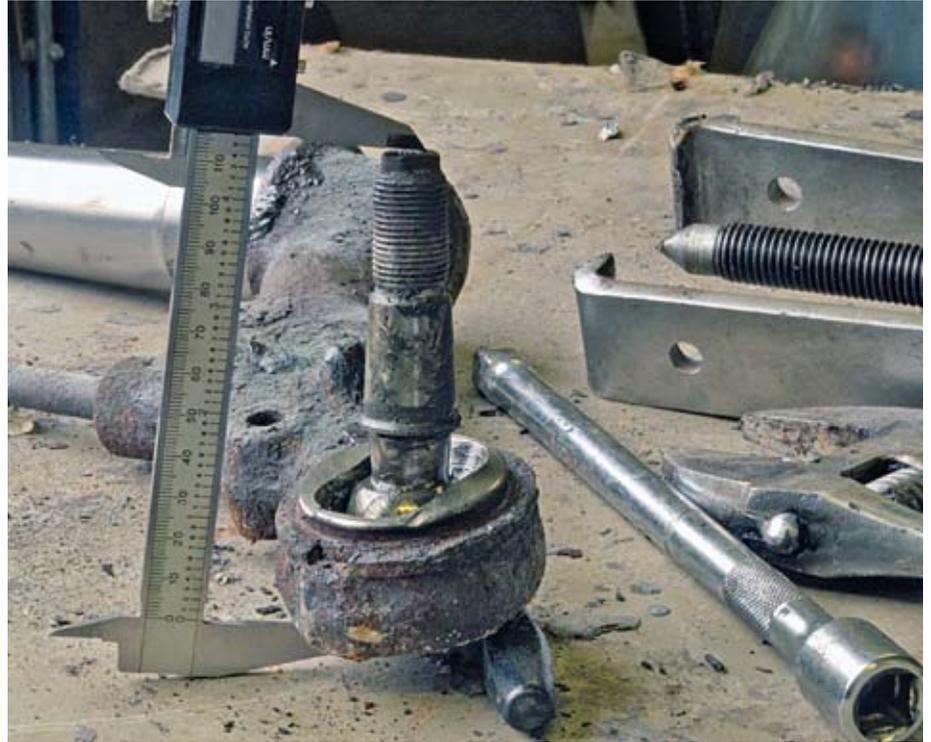
6.45 Wear is often detectable simply by pulling and pushing the pin in relation to its seat as there should be no noticeable movement. You can double-check by using a micrometer and getting an exact figure, and comparing it with the factory specification.

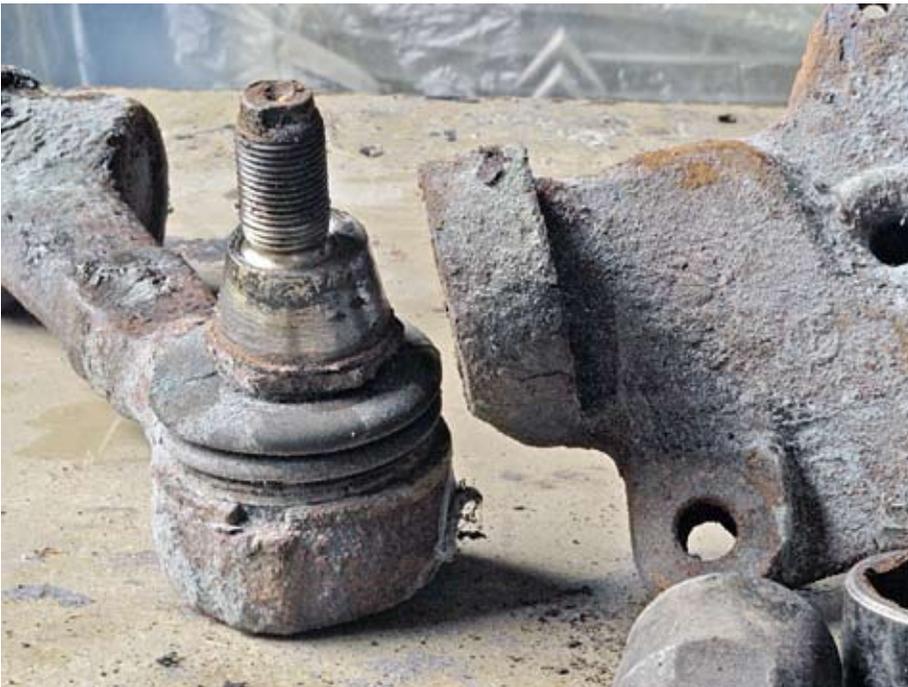
6.46 The top ball joint will respond to knocking the eye of the hub, and will come out with the camber sleeve still attached ...

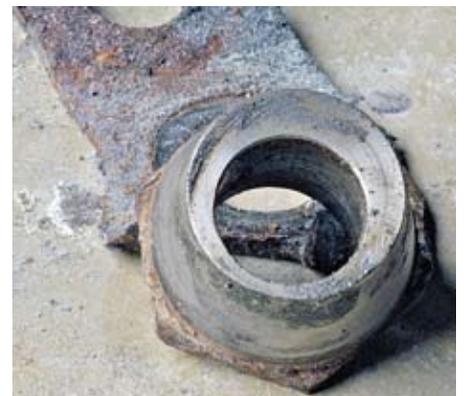
6.48 Once off, the eccentric machined into the camber bush is clearly visible.
